TECHNICAL SERVICE BULLETIN

SUBJECT: AC50-55 INCORRECT COUPLING FLANGE STUDS

Products Affected: CN201154, shipped in December 2008 and January 2009

Effective Date: 4-FEB-2009

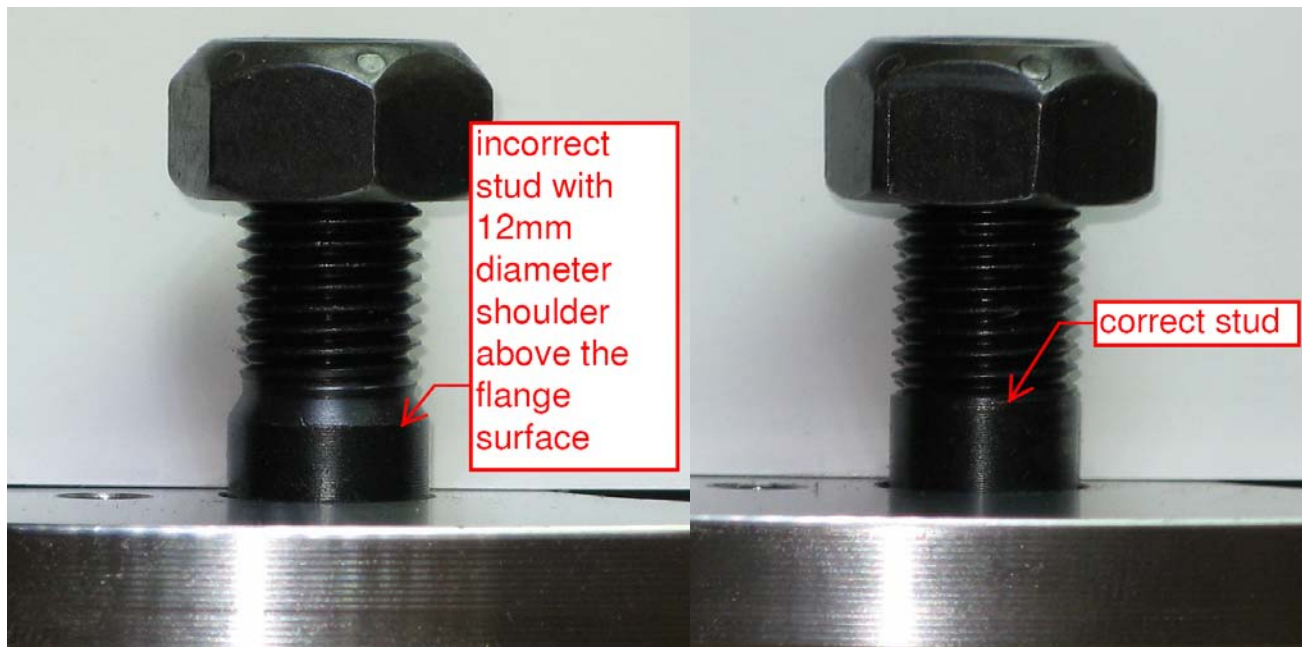
Telma model CN201154 shipped in December 2008 and January 2009 may have incorrect studs installed. On some units the flange studs may have an incorrect shoulder dimension. The problem did not occur in serial number sequence.

The incorrect stud has a shoulder diameter of 12mm which extends above the surface of the retarder flange face and does not allow the correct mating of flange yoke to the Telma companion flange.

Below are examples of the incorrect and correct studs.

On models that have the incorrect studs installed it is permissible to increase the diameter of the four holes of the flange yoke to 0.488 - 0.500 inches. This can generally be accomplished by using a ½" drill bit to increase the hole size in the flange yokes.

Note: Remove all burrs and metal shavings from the flange yoke to ensure a good mating of the two metal surfaces.
